Status of Livestock Water Sources in Karamoja Sub-Region, Uganda

Swidiq Mugerwa^{1,*}, Kayiwa Stephen¹, Egeru Anthony^{2,3}

¹National Livestock Resources Research Institute, Tororo, Uganda

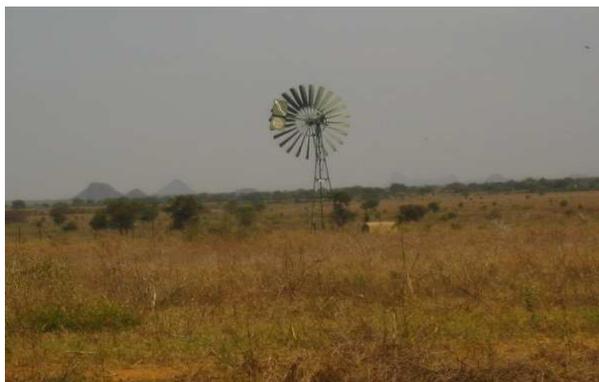
Figure 1. Lotome windmill in Napak District

Six sources of water exist in Karamoja for livestock depending on season and type of livestock. Boreholes, wind mills (Figure 1) and ponds fall in the first category of water sources utilized mainly to water small stock (goats, sheep and donkeys) mainly by small herders. Goats and sheep watered in these facilities are mainly those that remain within the manayattas. Valley tanks, dams (Figure 2 and 3) and rivers (Figure 4) and river beds provide the second category of water sources for livestock in Karamoja (Plates 1-4). Rivers are mainly utilized during rains while during desperate periods, river bed sand dugout wells are utilized to water livestock in the major rivers. Dams have proven to be useful sources of water for livestock; in Moroto and Napak; Kobebe and Nakicumet dams respectively have proven most important dams. Since their construction, these dams have barely dried. They have thus become convergence points for livestock when the water scarcity problem intensifies in the surrounding districts. Kobebe dam for example hosts the Matheniko and some Tepeth pastoral communities from Rupa sub-county and slopes of mountain Moroto respectively located in Moroto District, Jie pastoral community from Kotido District and Turkana pastoralists from Kenya while Nakicumet dam provides for the Bokora and the Pian pastoral communities from Napak and Nakapiripiriti (particularly those from around Lorengdwat and Nabilatuk sub-counties) respectively.

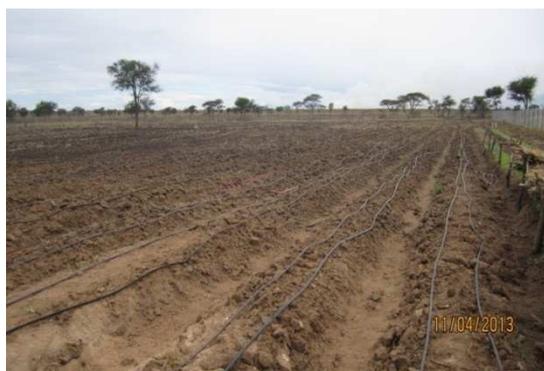
**Figure 6.** Prepared gardens laid with drip irrigation pipes at Nakicumet

March/April of the following year. It is important to note that the water in Nakicumet dam is currently serving multiple benefits including irrigation purposes (Figures 6 and 7) and fish farming (one fish pond has been set-up at Nakicumet).

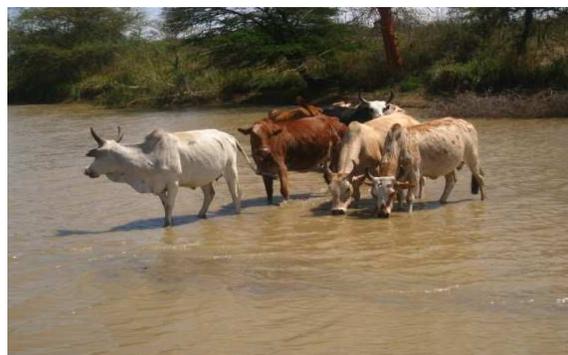
Figure 8. Direct watering of livestock in Lomogol dam in Kotido District

- Direct livestock watering, in all the dams visited, livestock were watered directly in the dam. This destroyed the dam embankments, exposed the dam to siltation and soil erosion. Despite observing a few goats and sheep being watered in Nakicumet-Arecheke dam, it was generally not a common practice. The herders here seemed to observe the set standards in using the watering troughs located across the road, about 2 km from the dam on the northwestern trending.

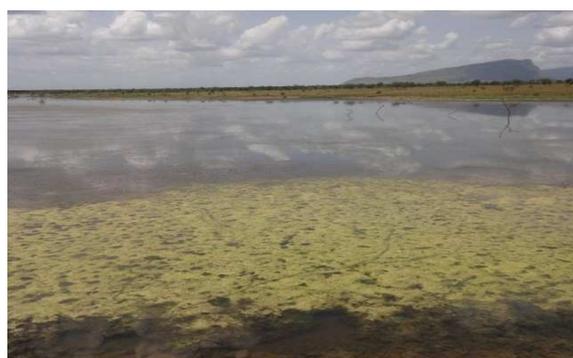
Figure 9. A greeny water weed blooming in Nakicumet dam

- Limited capacity and lack of equipment for managing expansive dams in particular Nakicumet and Kobebe dam. Nakicumet and Kobebe dam are very large dams and fairly deep. These require specialized equipment for removing water weeds that cover the water in the manner of an algae bloom.

- Existing management committees need specialized training in managing water sources. The current expansive water sources such as Kobebe, Nakicumet and other considerably larger size dams have not been in existence as such the communities are in a learning process and continued support will be vital. They equally need to be supported with specialized equipment such as boats to
